Troubleshooting for DS-9664NI-I8 issues

Product Name: DS-9664NI-I8

Time: 2023.12.02

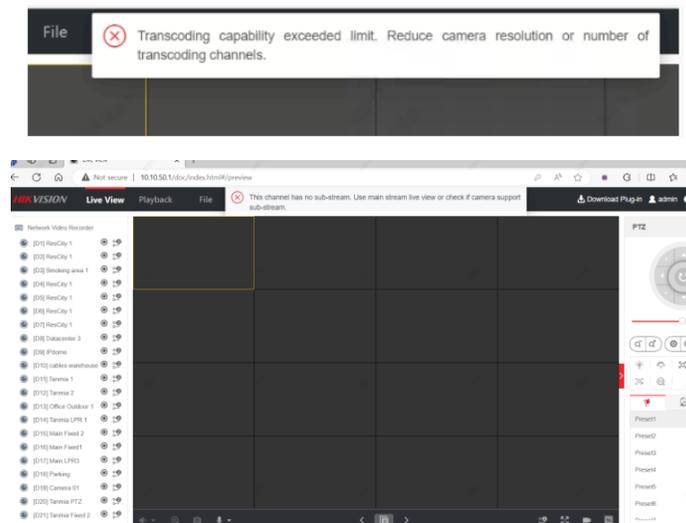
The End-user says that when they try to view the live-view on NVR webpage through PC, the webpage show the errors about Transcoding capability exceeded limit and This channel has no sub-stream.

Figure1: Errors Description

After briefly check the NVR and cameras status, found that this NVR is loading with 50 channels Hikvision cameras and the decoding capability of the NVR is not enough to decode this number of channels of cameras. If the end-user wants to see the 16 divisions on the webpage at the same time, the NVR will switch to the sub-stream automatically but at this case it pops up with channels don't support sub-stream error.

All hikvision cameras should support sub-stream so we jump to the camera webpage and check the camera sub-stream information.
